## Fire Performance Testing of an External Cladding System BS 8414-1:2015 + A1:2017

### Test Report

Prepared for : ROCKWOOL BV / Rockpanel  
Project : Classification of Rockpanel Durable 8mm  
Report No. : DLR1509 Rev.0  
Sample : Rockpanel Durable 8mm with ProtectPlus Finish and  
125mm ROCKWOOL Rainscreen Duo Slab Insulation

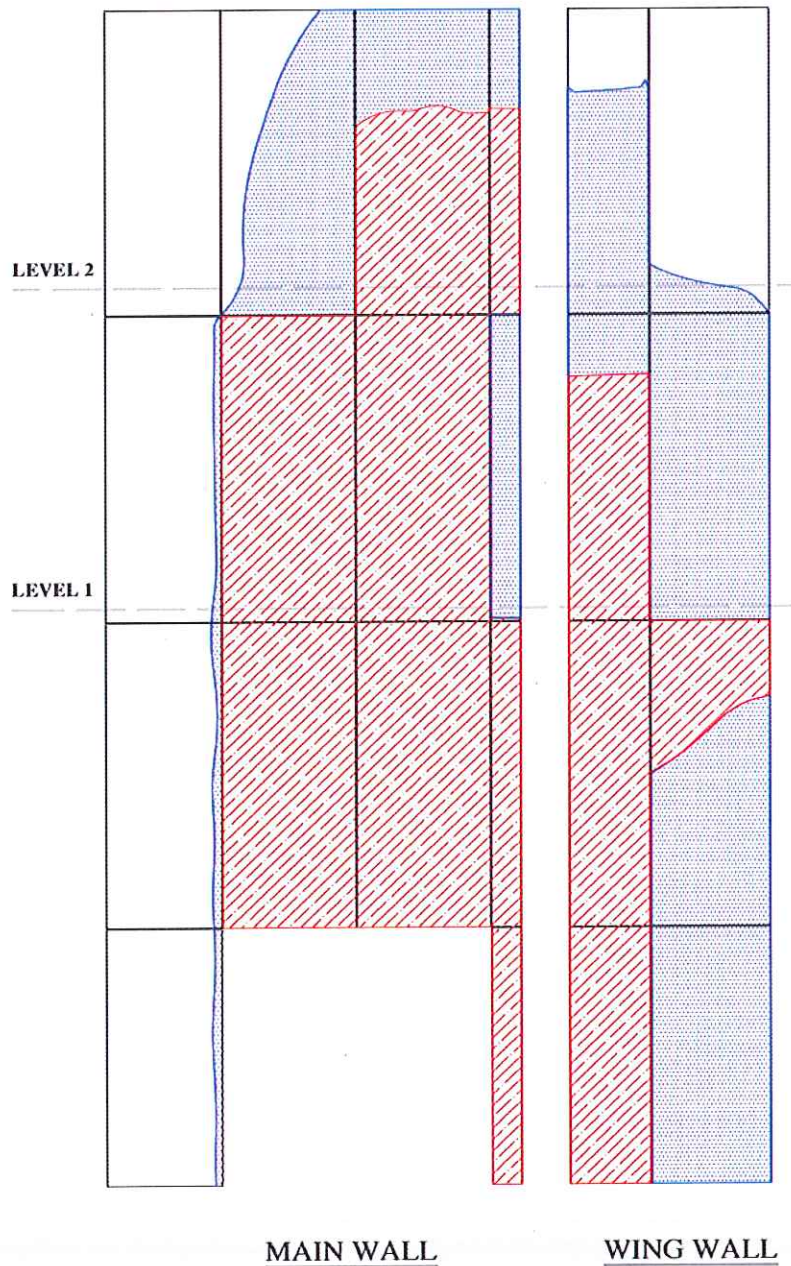
Figure 9 Area Map Showing the Condition of the Rockpanel boards after the Test

Sl. No.	Components	Observation	Photo Reference
1	Rockpanel boards	<p>Panels M1, M3, M7 &amp; M11 – No material loss on the panels. Minor discoloration observed.</p> <p>Panels M2, M4, M5, M8 &amp; M9 – 100% material loss observed.</p> <p>Panels M6, M10, M13 &amp; M14 - Approximately 60% of the panel fell off during the testing. Remaining area was discoloured and buckled.</p> <p>Panel M12 – Approximately 50% of the panel was discoloured.</p> <p>Panels W1 &amp; W3 - 100% material loss observed.</p> <p>Panels W2 &amp; W6 – 100% of the panel was discoloured.</p> <p>Panel W4 - Approximately 20% of the panel fell off during the testing. Remaining area was discoloured.</p> <p>Panel W5 - Approximately 80% of the panel fell off during the testing. Remaining area was discoloured.</p> <p>Panel W7 - No material loss on the panels. Approximately 80% of the panel was discoloured.</p> <p>Panel W8 - No material loss on the panels. Approximately 10% of the panel was discoloured.</p>	<p>DLP C2858/0011</p> <p>See Figure 9 in this section for the damaged areas</p>

100% MATERIAL LOSS

DISCOLORATION

- Approximately 17m<sup>2</sup> of the total external visible area fell off.
- Approximately 10m<sup>2</sup> of the total external visible area was discoloured.
- Approximately 11m<sup>2</sup> of the total external visible area had no damage or discoloration

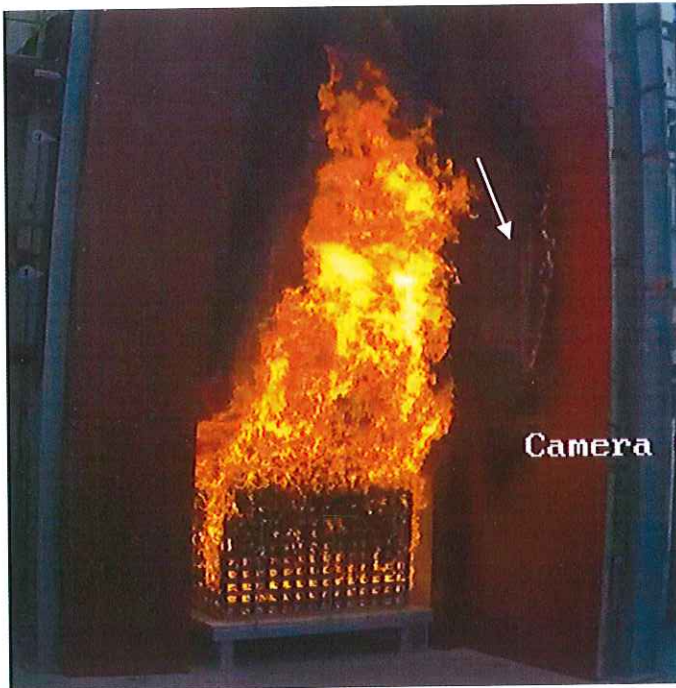
06:19:07	474	Sustained flames on the face of panel W3.	-
06:19:18	485	Discoloration on panels W3 & W4.	DLP C2858/0001
06:20:10	537	Flame tip reached 4m above the combustion chamber.	-

DLP C2858/0001 Discoloration on panels W3 & W4.

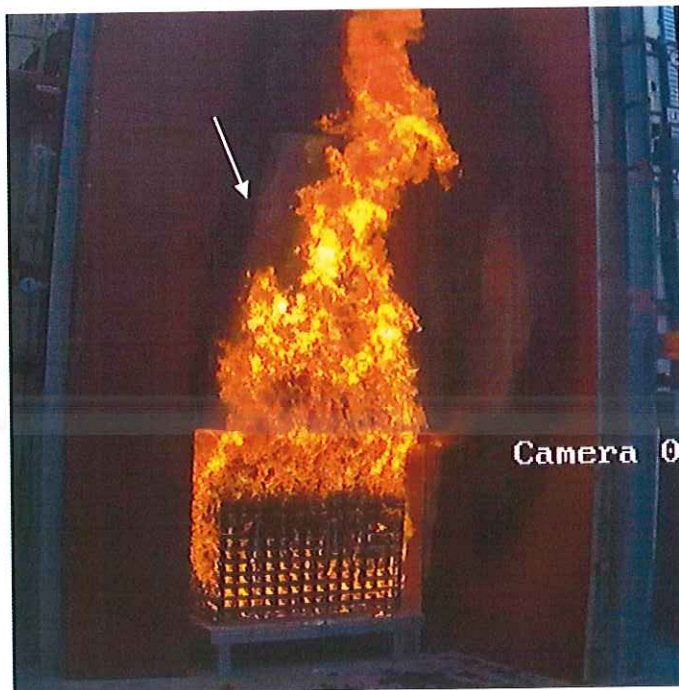
06:22:14	661	Approximately 50% of panels M4, M5 & W3 discoloured.	DLP C2858/0002
06:24:38	805	Discoloration on panel W1.	
06:24:45	812	Panel M5 detached partially and flame on the insulation behind the panel.	DLP C2858/0003

DLP C2858/0002 Approximately 50% of panels M4, M5 & W3 discoloured.

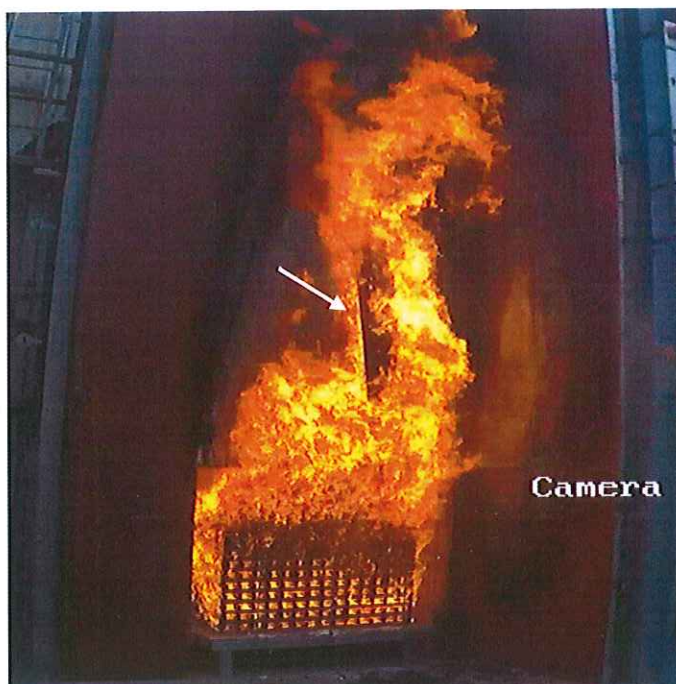
DLP C2858/0003 Panel M5 detached partially and flame on the insulation behind the panel.

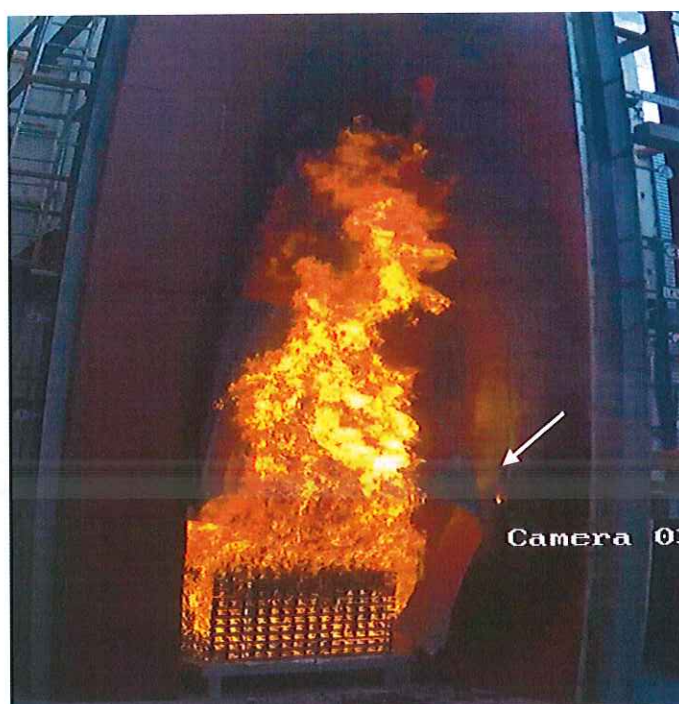
06:25:32	859	Self-sustained flame at the panels W3 & W4 vertical joint.	-
06:25:55	882	Panel M5 fell off the main wall.	DLP C2858/0004
06:26:01	888	External paint finish on panels M12 started peeling off.	-

DLP C2858/0004 Panel M5 fell off the main wall.

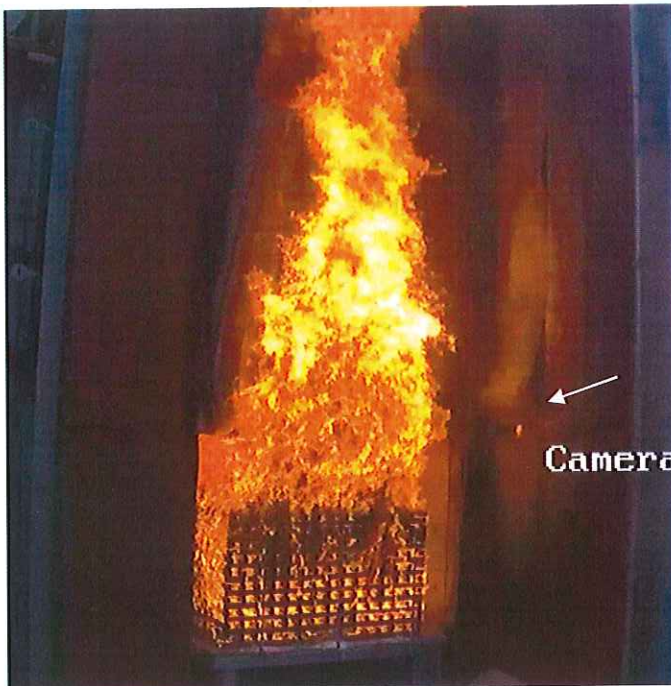
06:26:12	899	High intensity flame behind panel M4.	
06:26:41	928	Sustained flames behind panels W1 & W3.	DLP C2858/0005
06:27:49	996	Panel M4 detached and fell off the main wall.	DLP C2858/0006

DLP C2858/0005 Sustained flames behind panels W1 & W3.

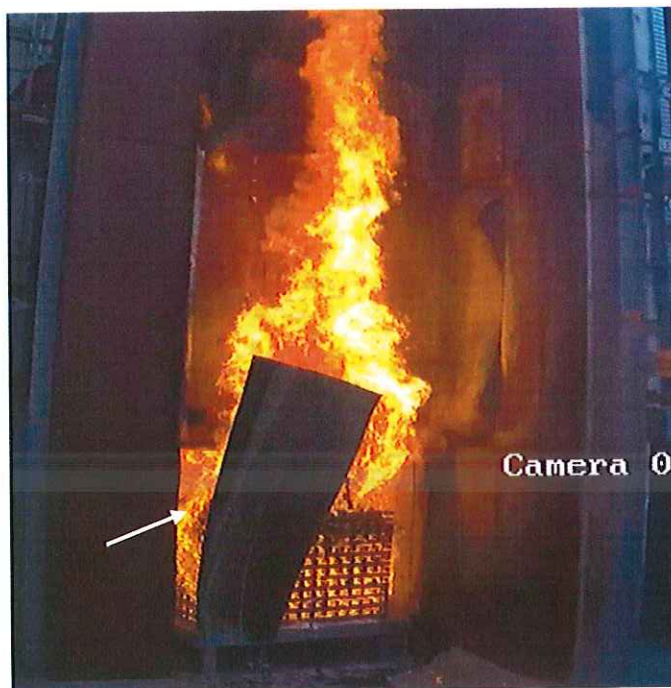
DLP C2858/0006 Panel M4 detached and fell off the main wall.

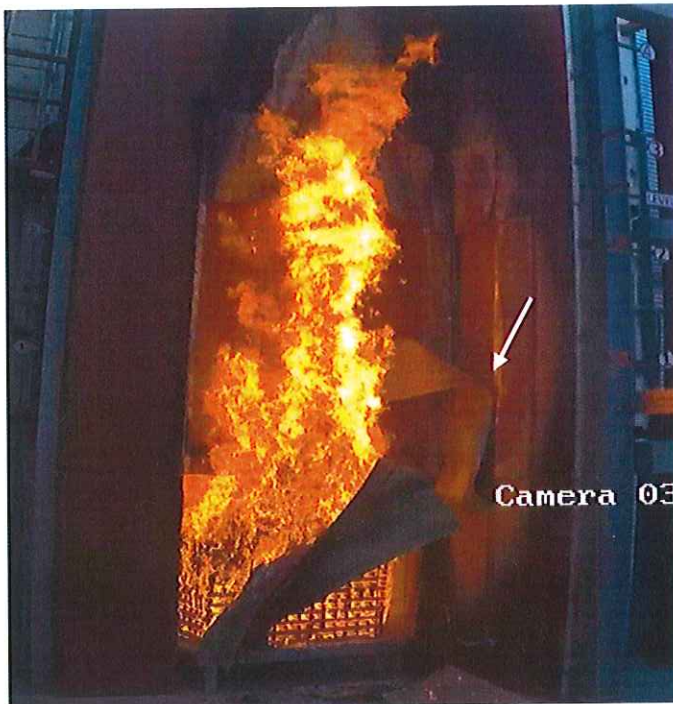
Time	Seconds	Observation	Photo Reference
06:28:20	1027	Railings behind panels M4 and M5 melted.	-
06:28:59	1066	Panel W3 detached and fell off the wing wall.	DLP C2858/0007

DLP C2858/0007 Panel W3 detached and fell off the wing wall

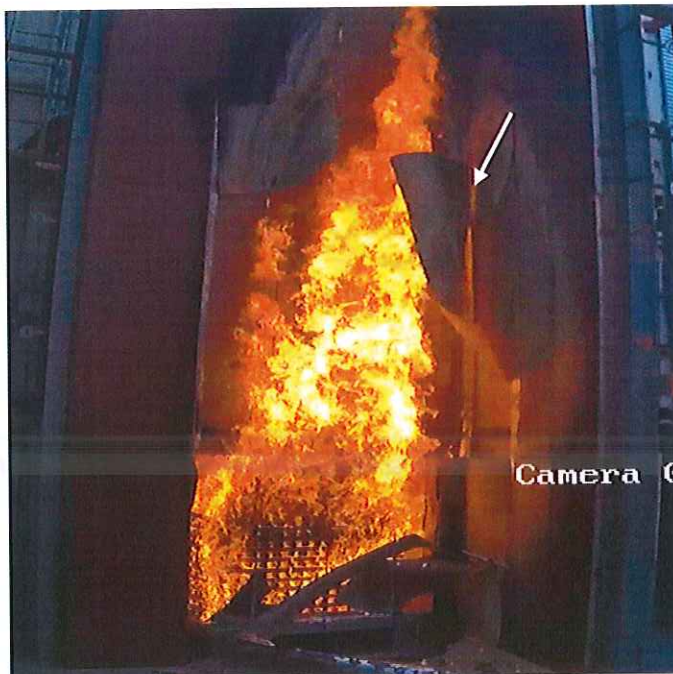
06:29:33	1100	Panel M6 detached and fell off the main wall.	-
06:29:53	1120	Flame on the insulation and railings behind panel M8 & M9.	-
06:30:21	1148	Panel M9 detached and fell off the main wall.	DLP C2858/0008

DLP C2858/0008 Panel M9 detached and fell off the main wall.

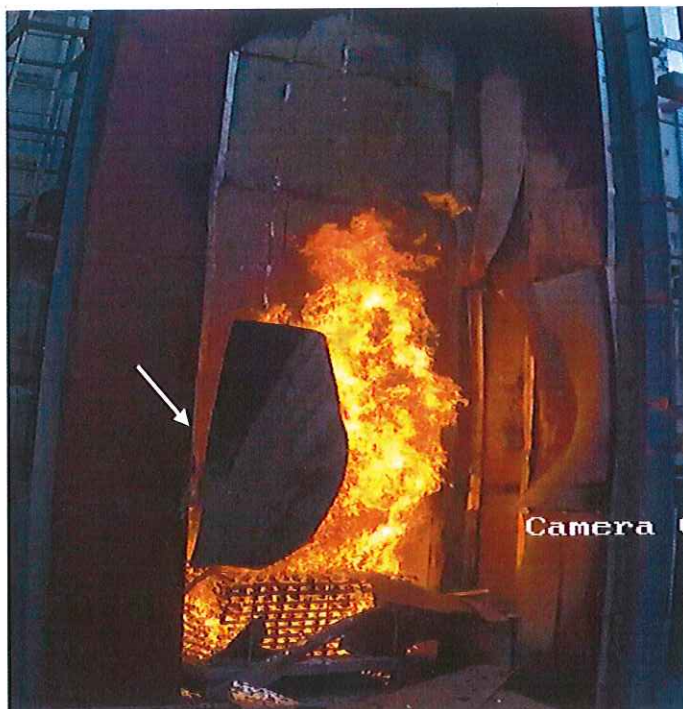
06:34:31	1398	Panel M2 detached and fell off the main wall.	
06:34:55	1422	Panel M8 detached and fell off the main wall.	DLP C2858/0009
06:40:00	1727	The heat source was extinguished, observation was continued for another 30 minutes.	-

DLP C2858/0009 Panel M8 detached and fell off the main wall.

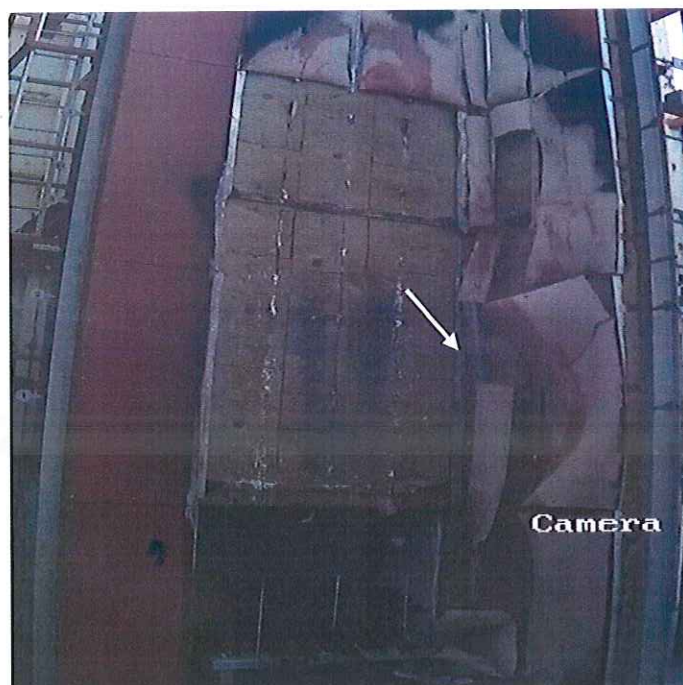
06:42:15	1862	All visible flames ceased.	-
06:47:38	2185	Debris of panels W4 and W5 fell off.	DLP C2858/0010
06:59:25	2892	No significant changes.	-
07:10:00	3527	Test was terminated 60min after the ignition.	-

DLP C2858/0010 Debris of panels W4 (top part) & W5 fell off.

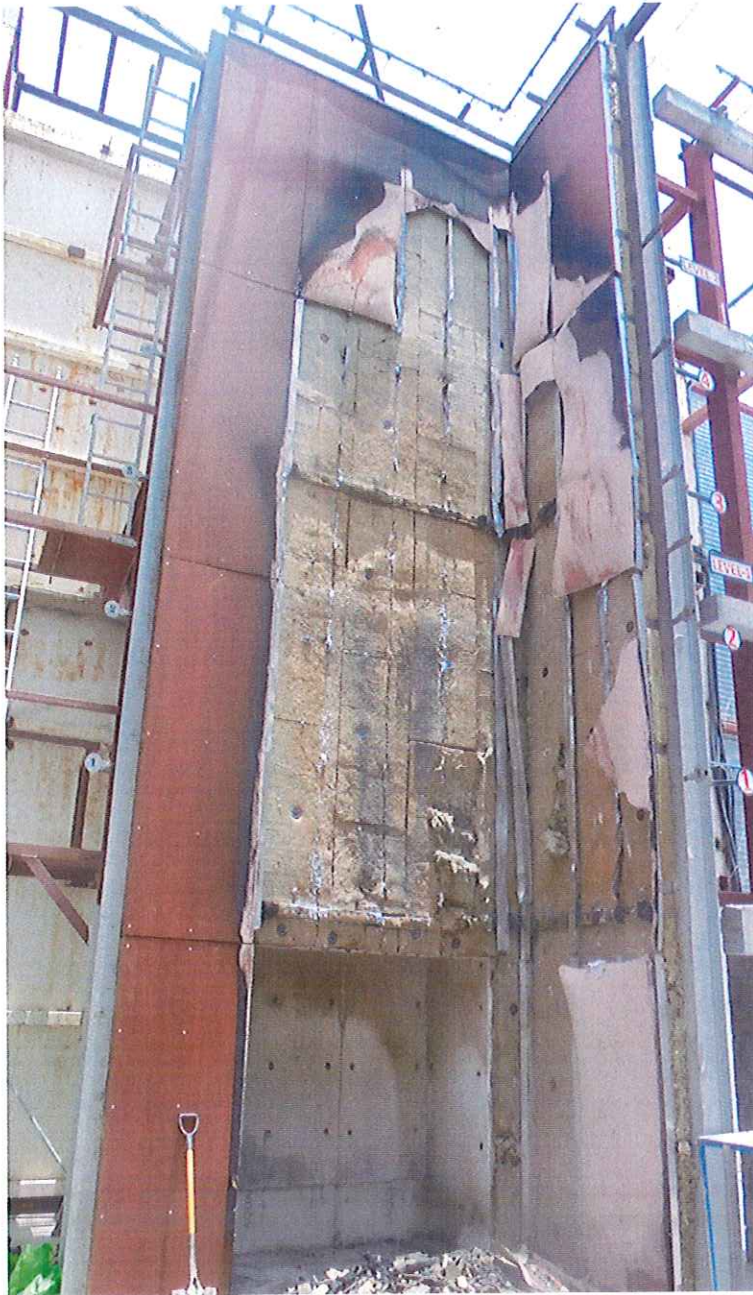
DLP C2858/0011

View of the sample after the test

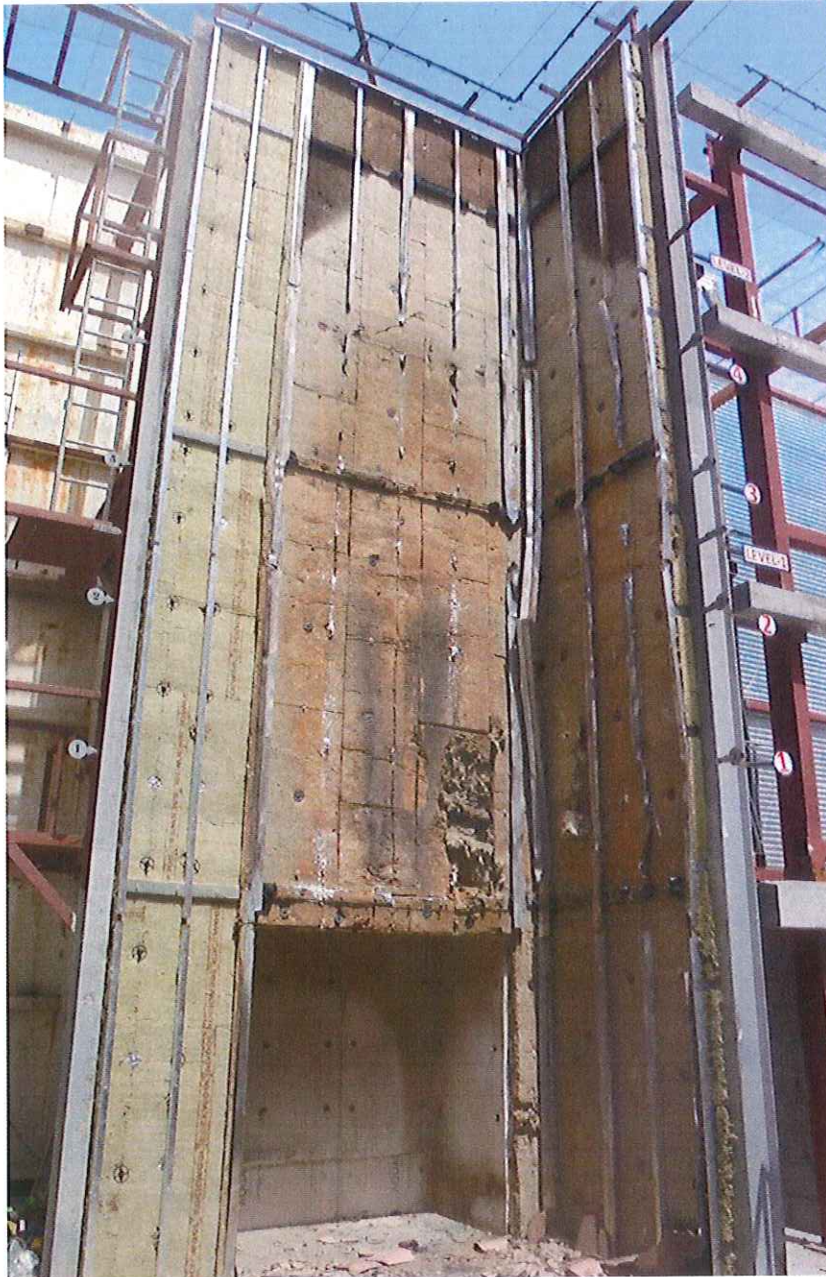
DLP C2858/0012

2	Cavity barrier	<p><b>Horizontal intumescent cavity barrier:</b></p> <p>Main wall:</p> <p>The 1<sup>st</sup> horizontal cavity barrier at 155mm above the combustion chamber was activated except the cavity behind panel M3. Intumescent layer was not present during the dismantling. Material loss and damage was observed.</p> <p>The 2<sup>nd</sup> horizontal cavity barrier at 3210mm above the combustion chamber was activated except the cavity behind panel M7. Intumescent layer was not present during the dismantling. Material loss and damage was observed.</p>	<p>DLP C2858/0012, DLP C2858/0013, DLP C2858/0014 &amp; DLP C2858/0015.</p>

3	125mm ROCKWOOL Rainscreen Duo Slab Insulation	<p>Minor material loss of the insulations behind the panels M5.</p> <p>Insulation behind panels M2, M4, M6, M8, M9, M10, M12, M13 &amp; M14 was discoloured.</p> <p>All other insulation on the main wall was in place and no damage was observed.</p> <p>Minor material loss of the insulation behind panel W3. All other insulation on the wing wall was discoloured and no damage was observed.</p>	DLP C2858/0012, DLP C2858/0013, DLP C2858/0014 & DLP C2858/0015.

Cavity barriers, insulation and railings

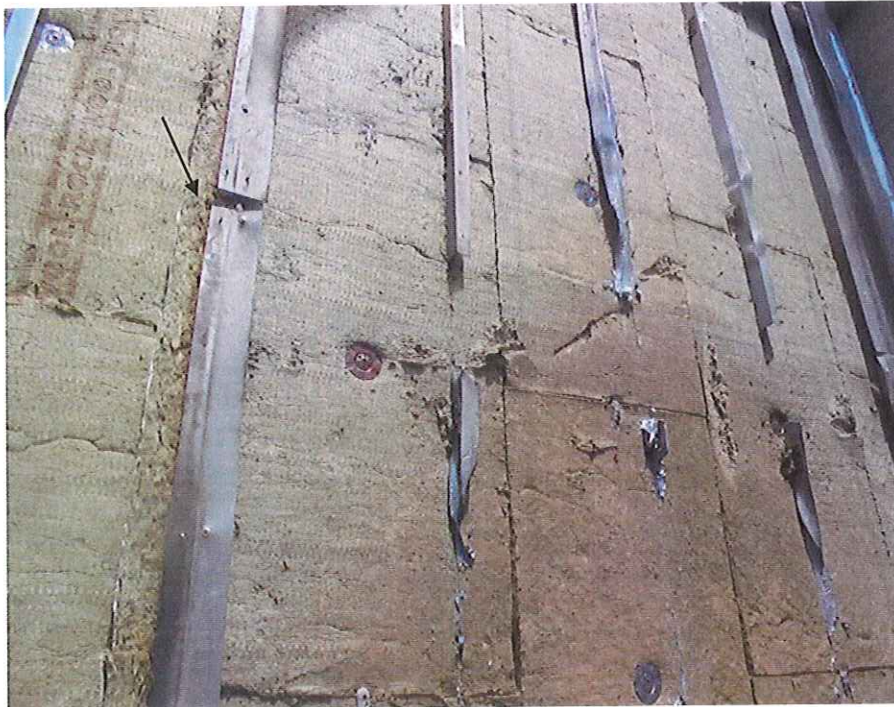
DLP C2858/0013

Vertical cavity barrier, insulation and railings

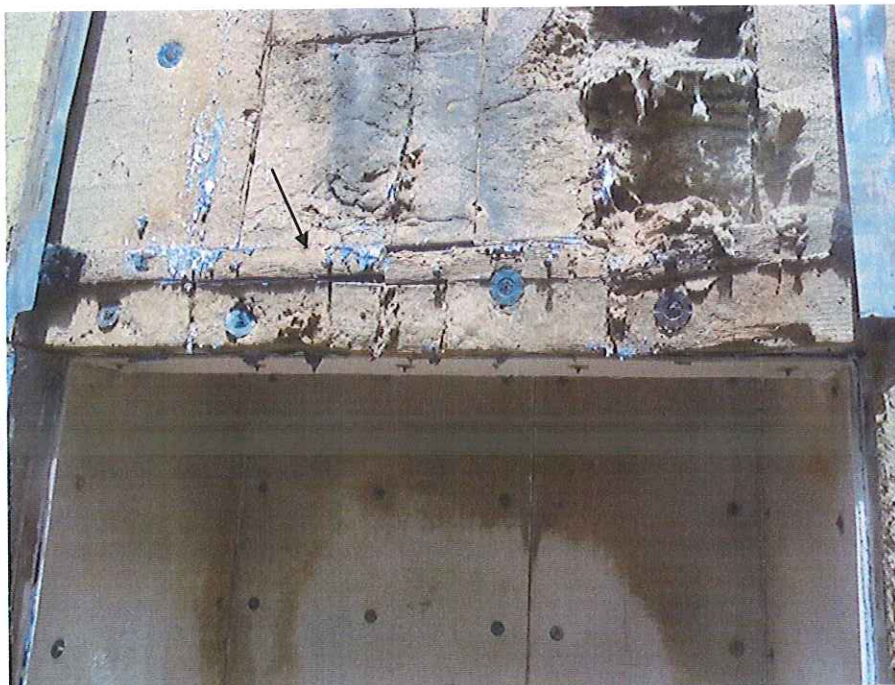
DLP C2858/0014

Cavity barrier at the top of combustion chamber

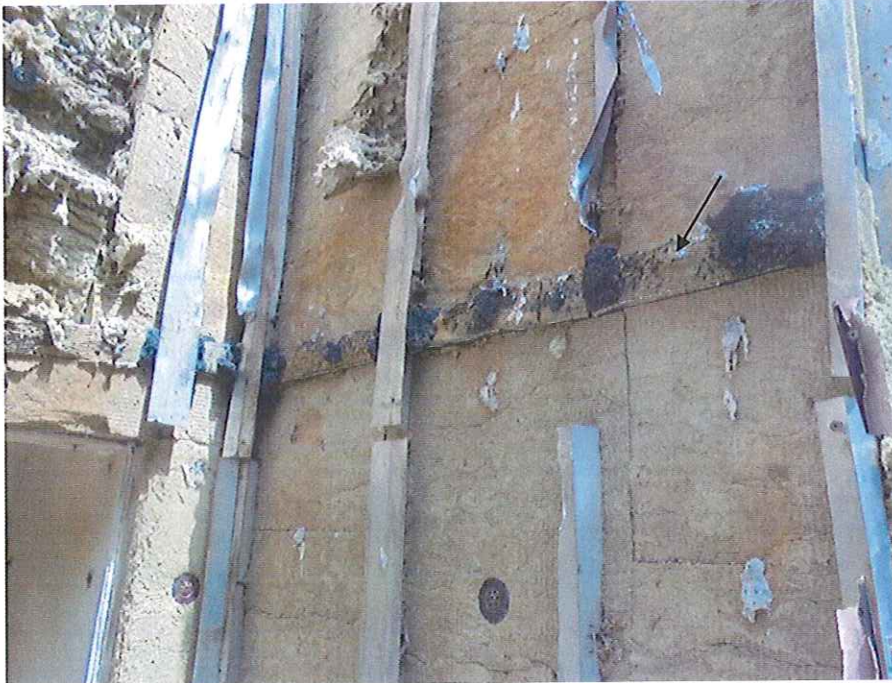
DLP C2858/0015

Sl. No.	Components	Observation	Photo Reference
4	Railing	<p>All railings behind panels M4 &amp; M5 were melted off.</p> <p>Railings behind panels M8 &amp; M9 were partially melted off.</p> <p>All other railings on the main wall were in place and no damage was observed.</p> <p>Approximately 10% of the railings on the wing wall were melted off. Remaining areas were discoloured and buckled.</p>	<p>DLP C2858/0012, DLP C2858/0013 &amp; DLP C2858/0015.</p>
5	Brackets	<p>All brackets behind panels M4 &amp; M5 were partially damaged.</p> <p>All other brackets were in place and no damage was observed.</p>	<p>DLP C2858/0015</p>

Cavity barrier on wing wall
