## Fire Performance Testing of an External Cladding System BS 8414-1:2015 + A1:2017

### Test Report

Prepared for : ROCKWOOL BV / Rockpanel  
Project : Classification of Rockpanel Durable 8mm  
Report No. : DLR1509 Rev.0  
Sample : Rockpanel Durable 8mm with ProtectPlus Finish and  
125mm ROCKWOOL Rainscreen Duo Slab Insulation

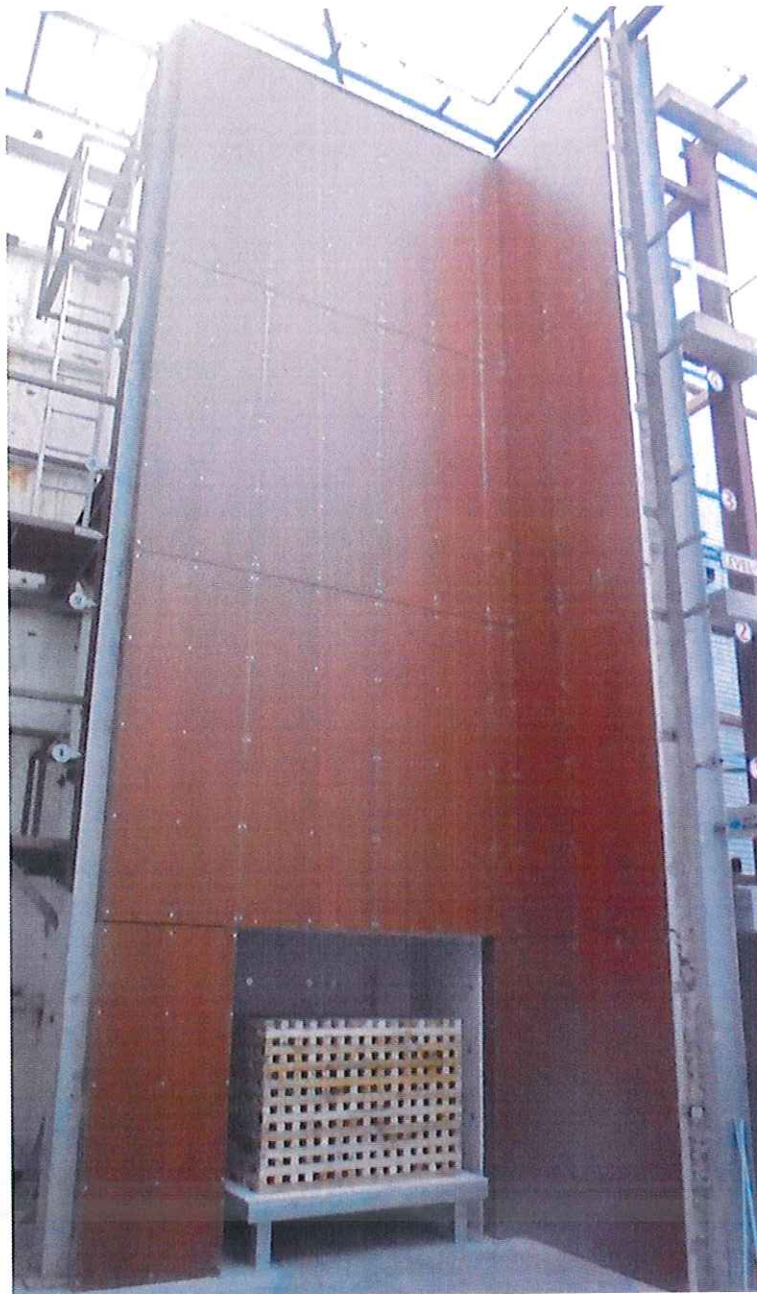
Figure 1 Photo DLP C2858/1162 External View of the Test Sample

Photo DLP C2858/1162 shows an external view of the sample.
